Inspection Report

Minerals Regulatory Program

Mine Name: Bingham Canyon Mine	Permit Number: M/035/0002
Operator Name: Rio Tinto - Kennecott Utah Copper	Inspection Date: May 10, 2012
Inspector(s): L Heppler, P. Brinton	Time: 8:00 AM
Other Participants: Zeb Kenyon and others	Mine Status: Active

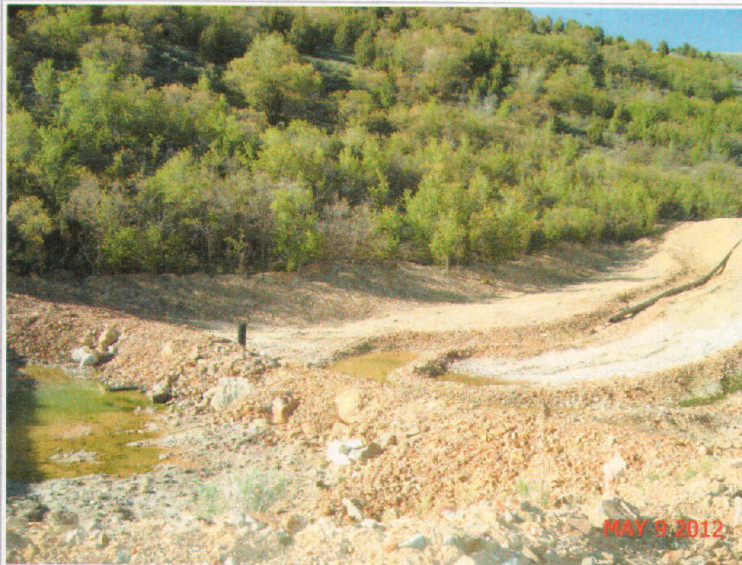
Sediment basin below dump

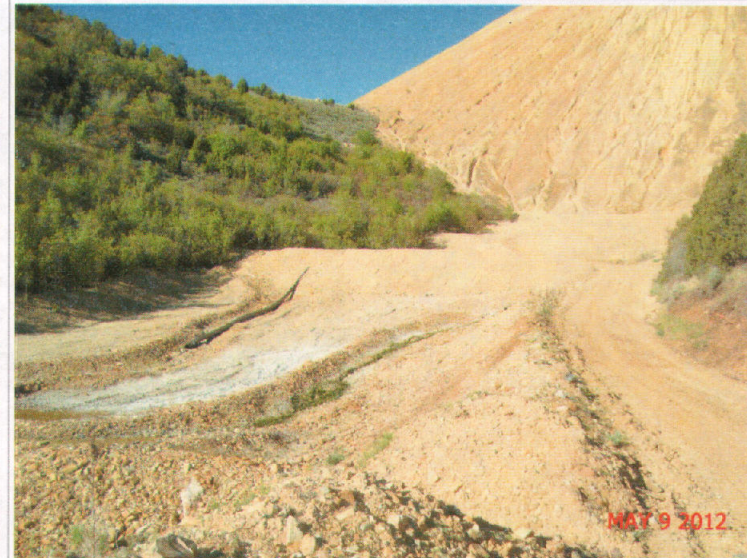
Sediment basin below dump

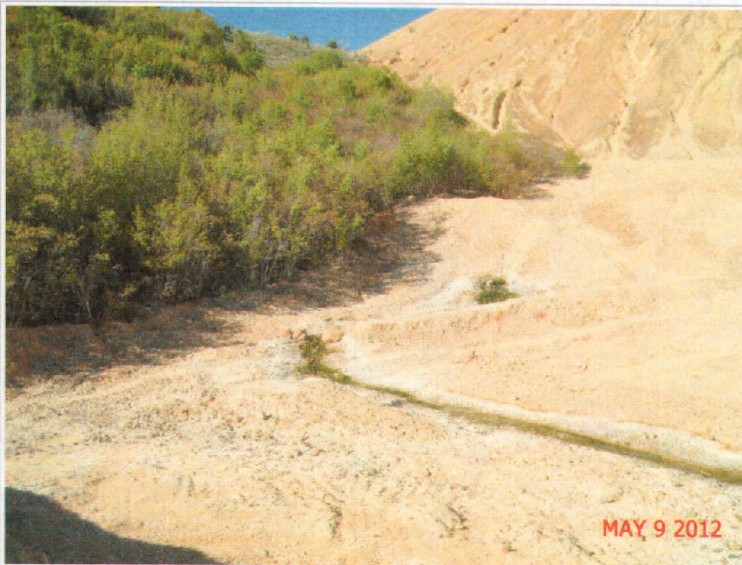
Details of upper part of sediment basin

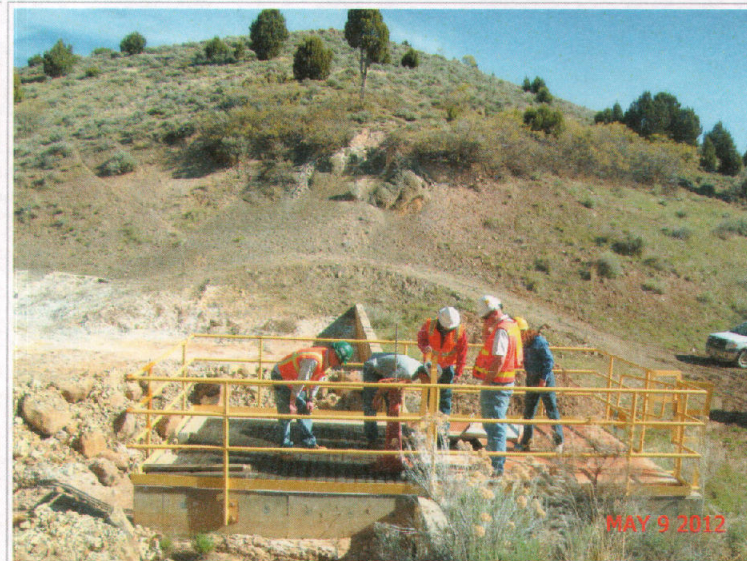
Lower overflow structure of sediment basin

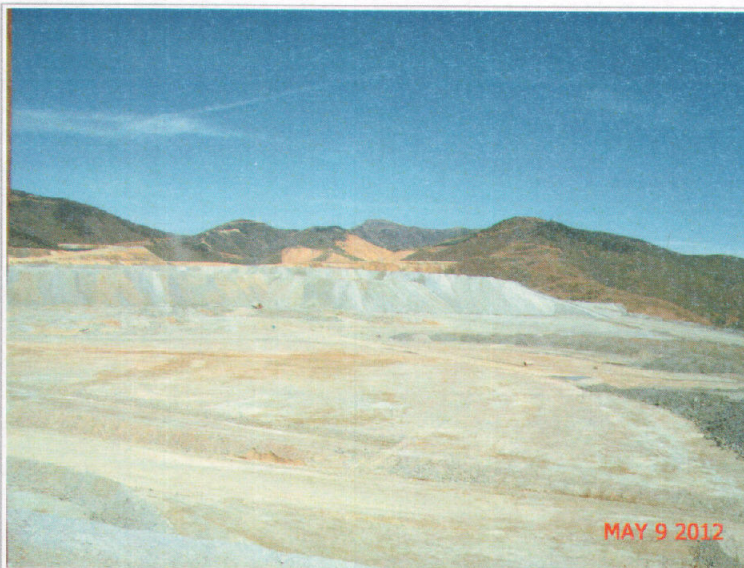
Active dump above reclaimed area

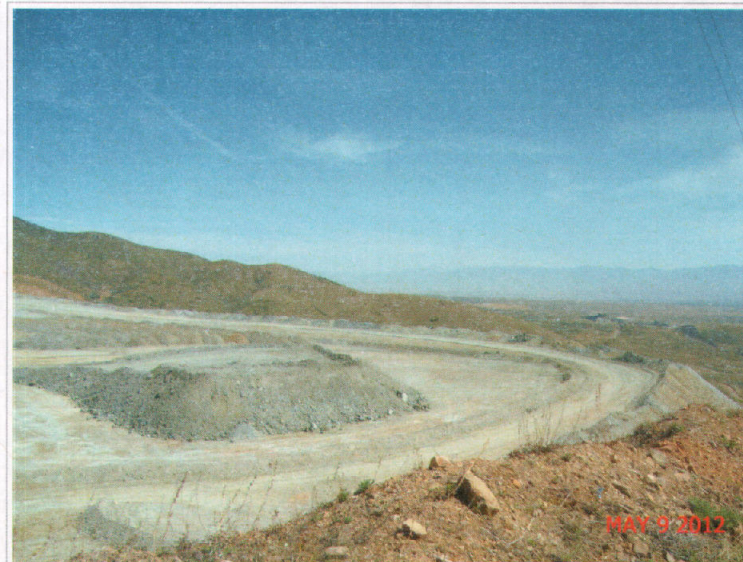
Active dump above reclaimed area

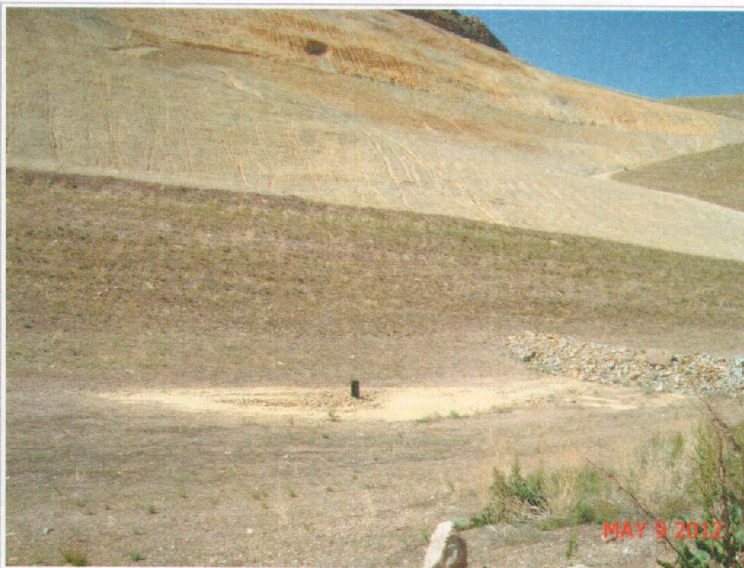
Sediment basin below reclaimed slope of dump

Conclusions and Recommendations: OGM recommends working on biodiversity of vegetation in areas that have been reclaimed. OGM to continue annual inspections and monitor the site when in the area

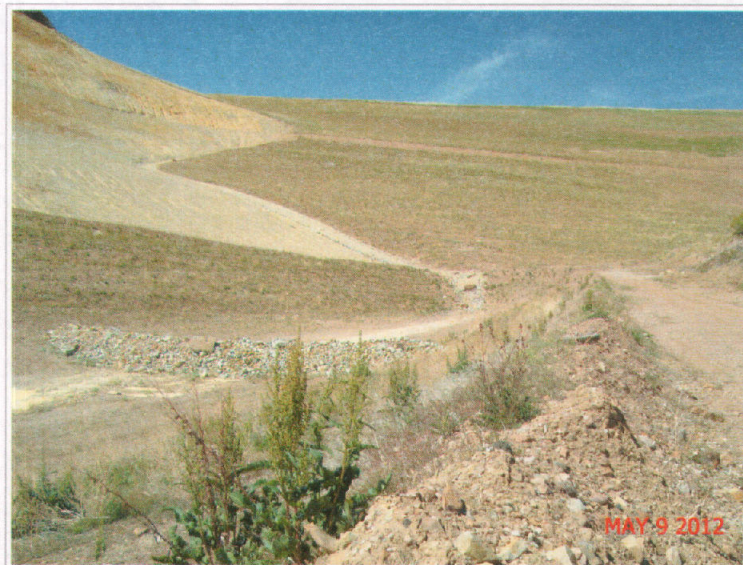
Upper reach of sediment basin and reclaimed slope (which is below active dump shown in pictures above)
